# Validation checklist & planning statement

Proposed Structural  
Repair Works to  
Topsham Museum,  
25 Strand, Topsham,  
Exeter, EX3 0AX

Produced for and on behalf of  
Exeter City Council

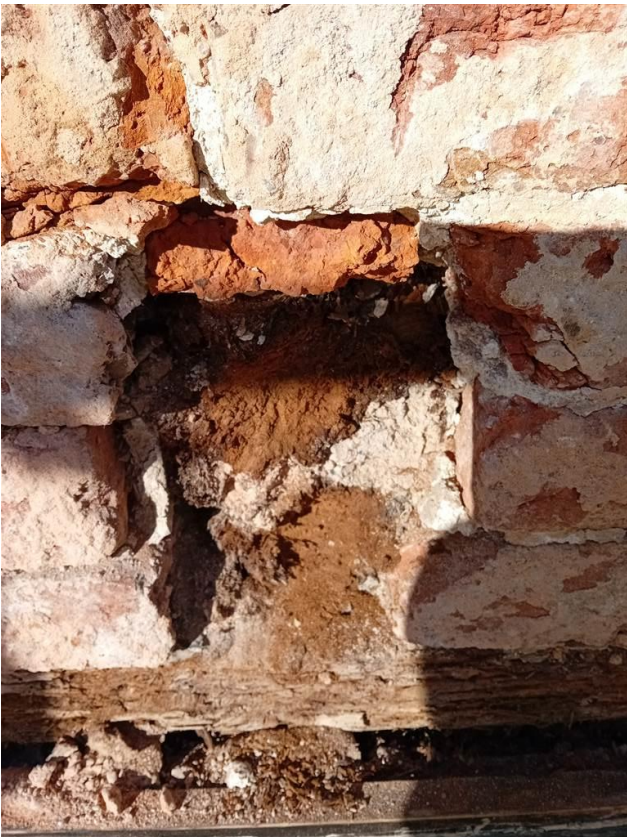
**Photo 10:** Merchants House: Typical view of the end of the bottom chord of the roof truss following removal of the external render.

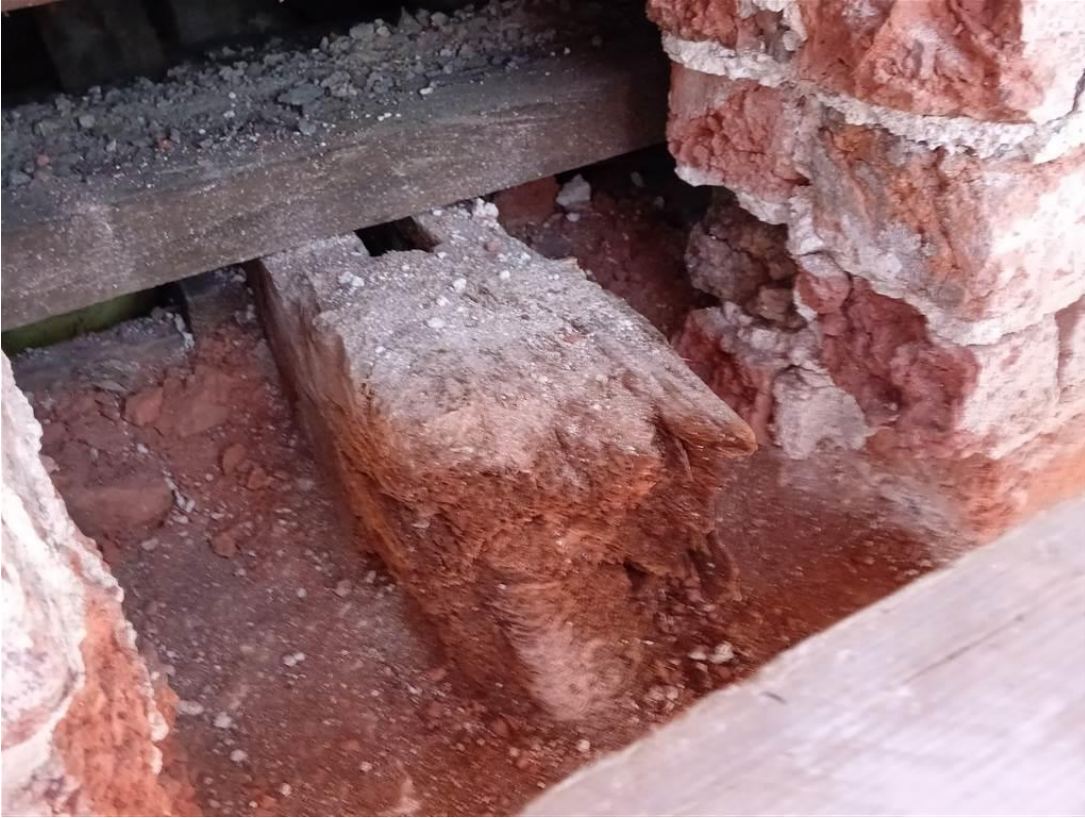
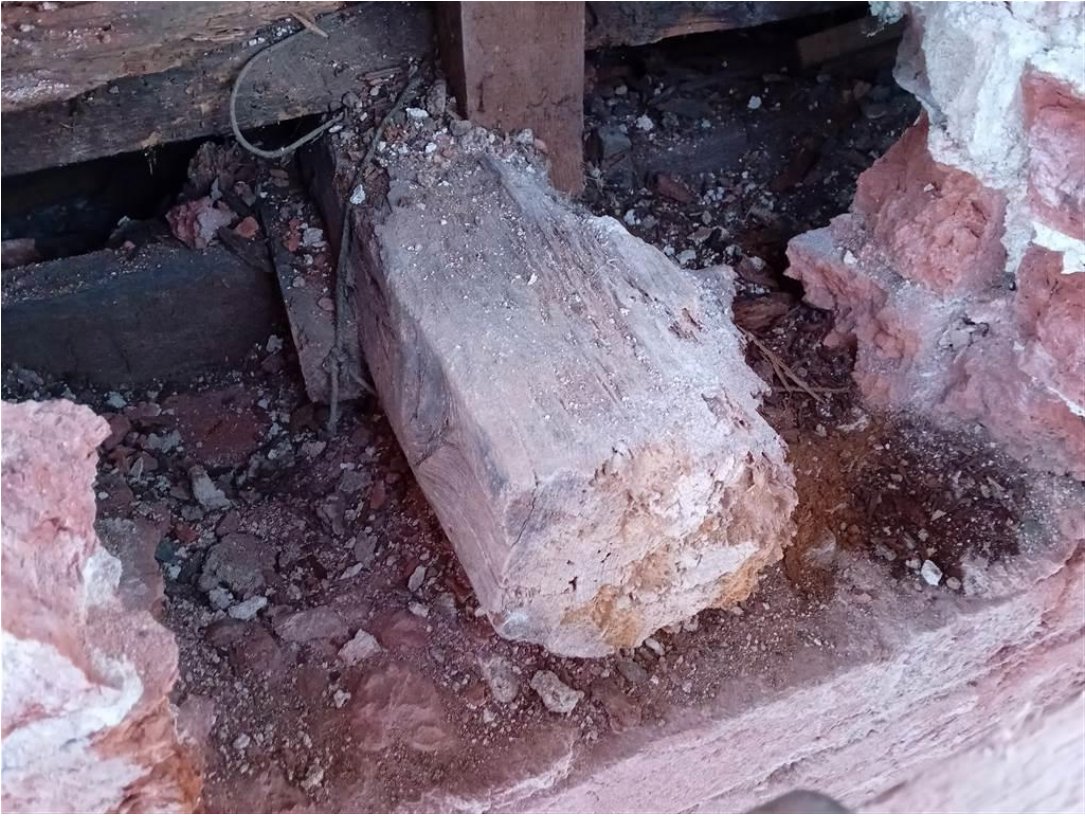
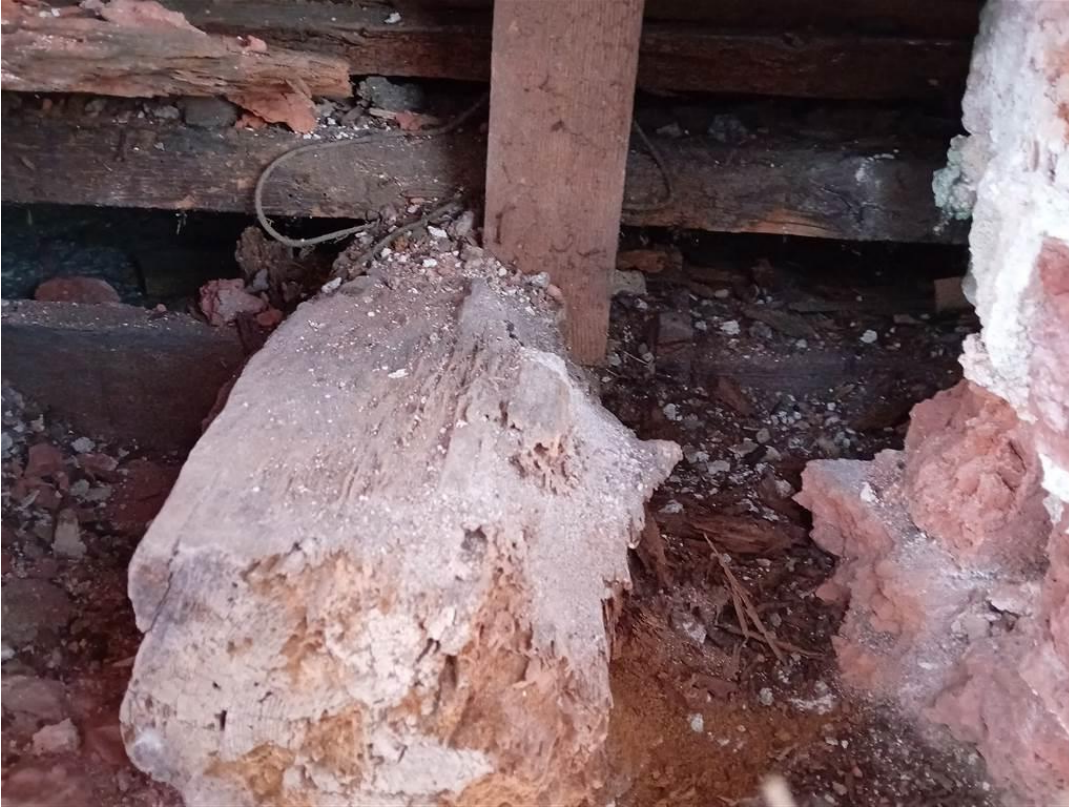
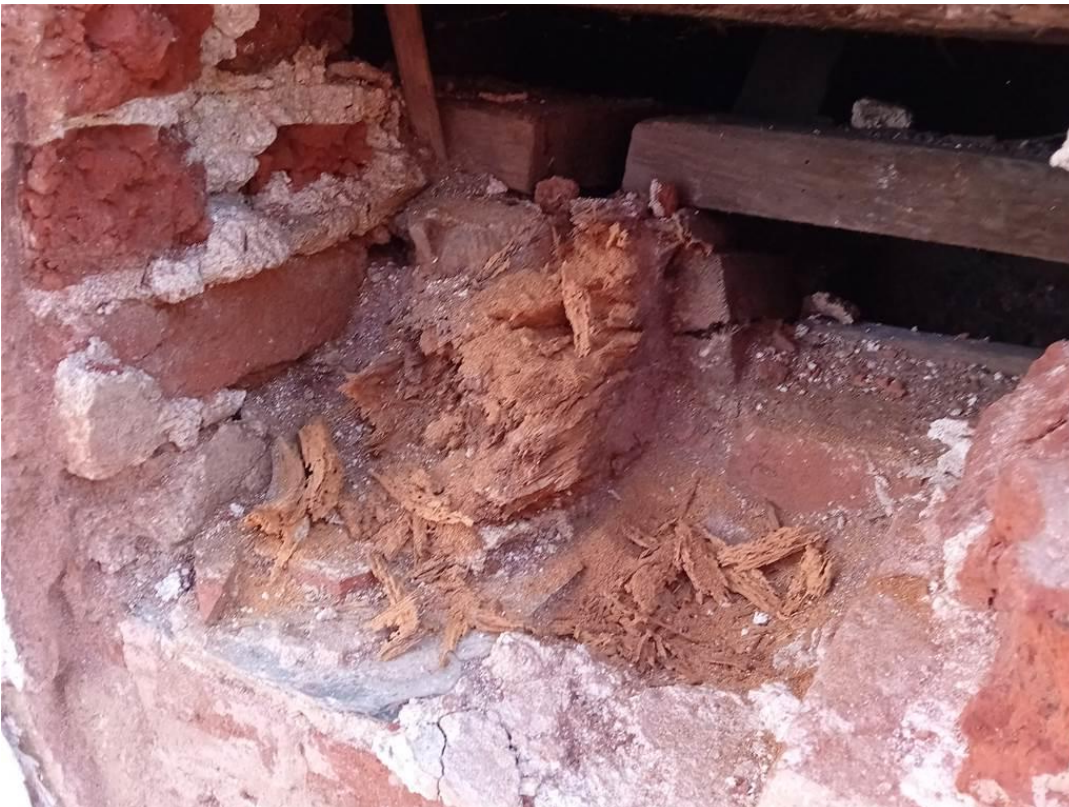
The overall condition of the roof truss timberwork is good, but investigations on site have revealed that the section of the bottom chords built into the brickwork external walls has rotted away significantly. See Photos 11 to 14. The extent of rot varies depending on the original size and quality of the wood but in all cases the structural integrity of the truss is impaired and the bearing onto the masonry significantly reduced. These defects require urgent strengthening works to properly transfer the roof loads to the external walls.

**Photo 11:** Merchants House: View of the bottom chord of a roof truss built into the external walls.

**Photo 12:** Merchants House: View of the bottom chord of a roof truss built into the external walls.

**Photo 13:** Merchants House: View of the bottom chord of a roof truss built into the external walls.

**Photo 14:** Merchants House: View of the bottom chord of a roof truss built into the external walls.

The proposed roof truss remedial works are detailed on drawing SWN-XX-00-D-B-012-P1, and comprise the installation of timber splices to the sides of the roof truss which extend into the masonry wall with a sound bearing onto the masonry. The splices will be formed to a neat and consistent arrangement from structural grade oak, and will be fixed by bolting through the bottom chord with stainless steel / galvanised steel bolts in the pattern shown on the drawing. This solution retains the integrity of the existing truss. To install the timber splices, a small area of the ceiling will need to be carefully removed to provide the access to install the timber splices from below. At these positions the lath and plaster ceilings will be supported and then made good on completion using traditional oak laths and lime plaster to match the existing. It is not feasible to install the timber splices from above, as this would involve dismantling a sizeable area of the parapet, and the removal of the roof covering and parapet gutters.

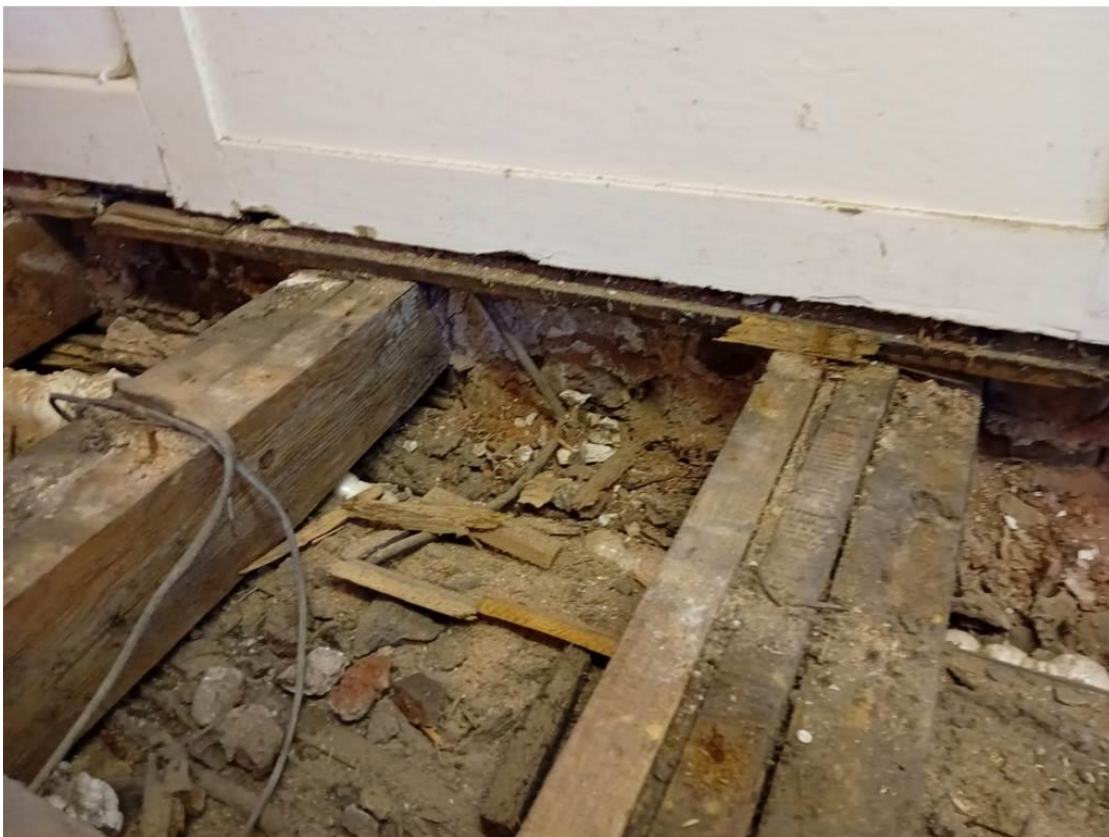
At second floor level the floor joists span across the full width of the house at around 500-600mm centres. The joists have varying section sizes but are typically around 160mm deep x 90-100mm wide. Based on current design standards these would be considered as undersized. Investigations of the joist ends shows they have rotted back in a similar way to the roof trusses but because they are smaller sections have failed much sooner. The most recent repairs appear to date from say the 60's or 70's, but there is evidence that much earlier repairs have also been carried out. A number of the joist ends are in urgent need of repair, and previous strengthening works need to be checked to see if they remain sound.

**Photo 20:** Merchants House: The floor joists in the 2<sup>nd</sup> floor 'Charles Potter Room' showing previous joist strengthening works.

- 1) Where joist ends have rotted away or there is inadequate bearing on the masonry wall, a new timber splice or steel angle will be bolted onto the side of the existing joist as the typical arrangement shown on drawing SWN-XX-00-D-B-016-P1. Generally where space allows timber splices will be used, but if access or site conditions make use of timber difficult, steel angle will be used as the alternative, either taken into the wall construction or provided with wing end plates to allow face fixing into the masonry.

- 4) Where existing splices are retained, additional bolt fixings will be provided to supplement the existing old fixings, in a similar arrangement to that shown on the drawings, but as directed by the structural engineer to suit site conditions.

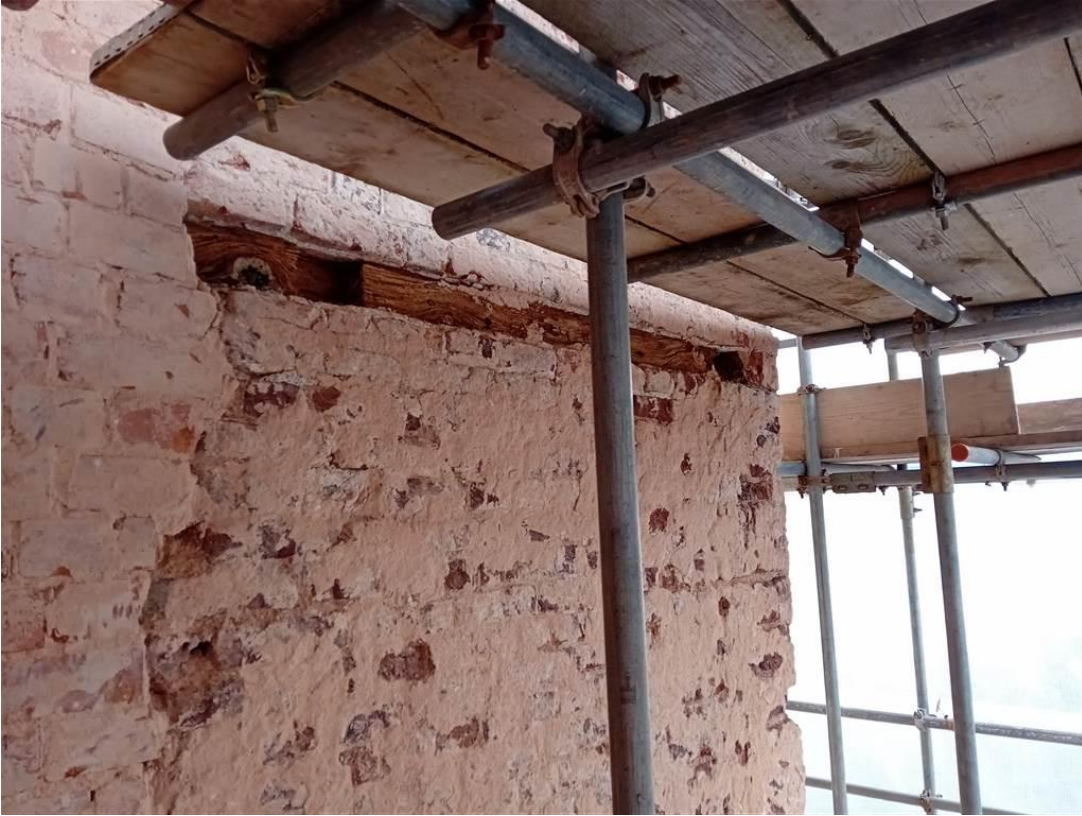
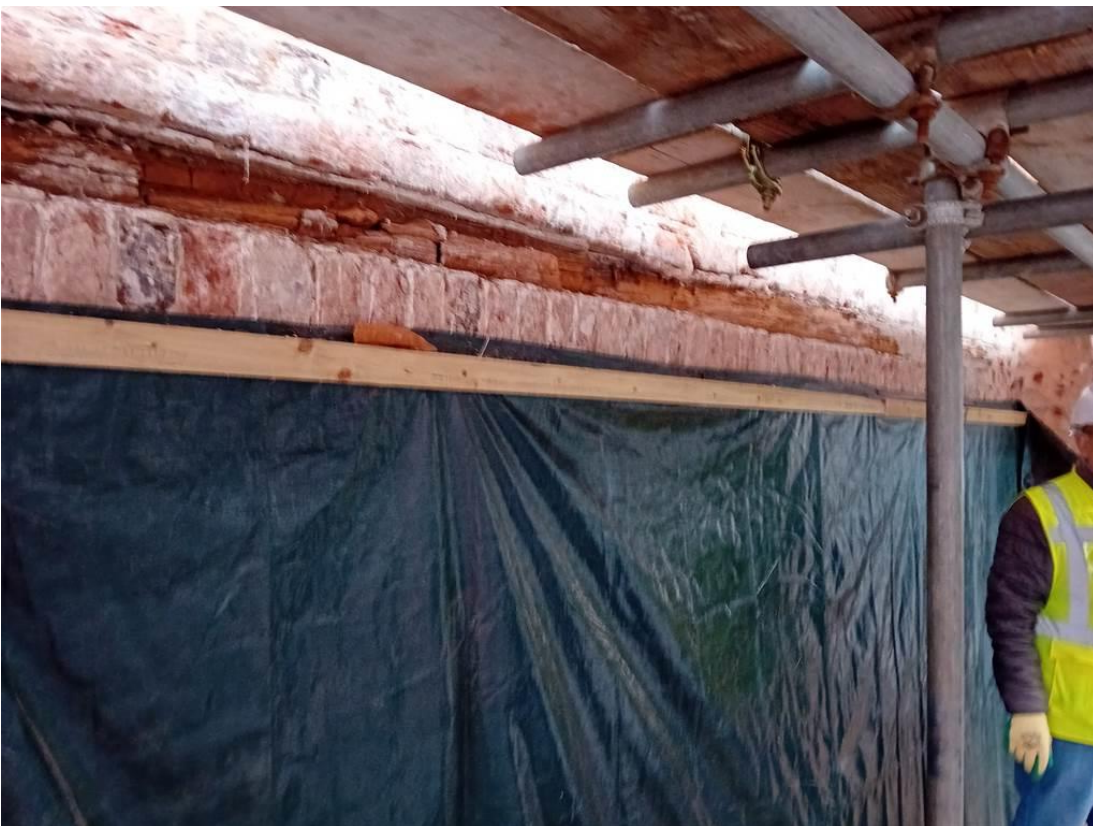
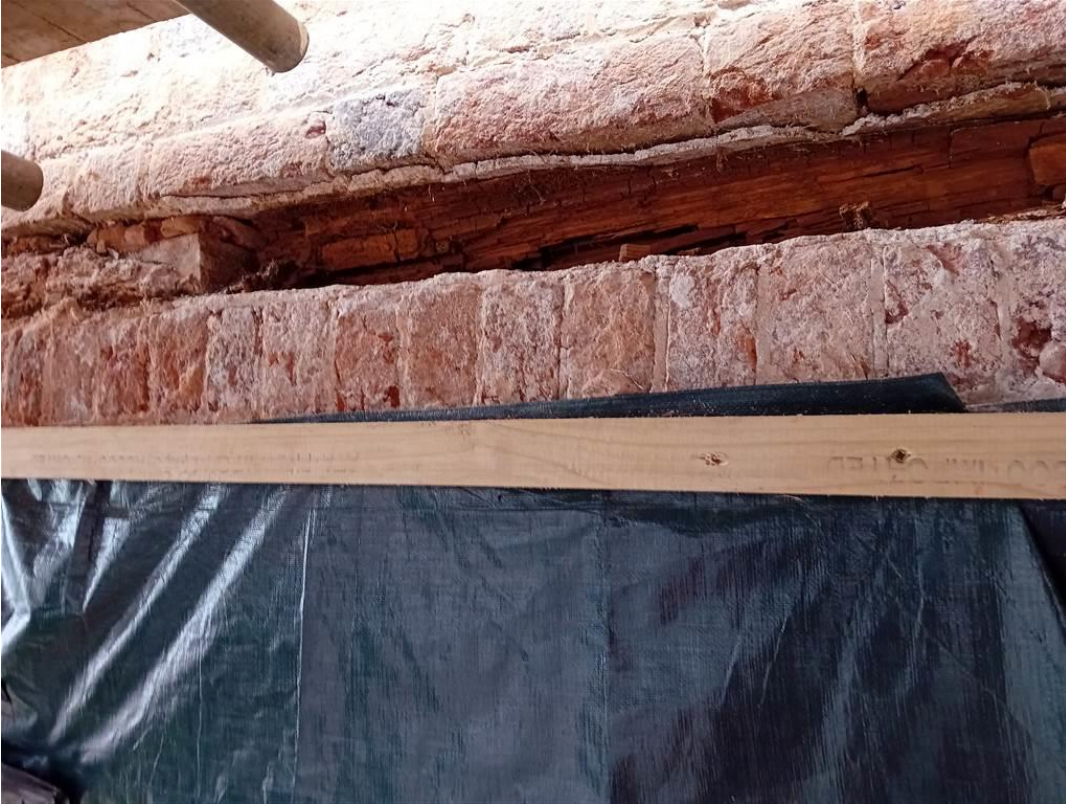
When the house was raised from two to three storeys the wall plates which supported the roof on the north elevation facing Lower Shapter Street were not removed. Instead, the brickwork was constructed on top of the timber but over the years these have gradually rotted back from the face of the wall resulting in the outer brickwork being unsupported. This issue was identified when the render was removed in preparation for application of a new external lime render.

**Photo 25:** Merchants House: Wall plate no.3 built into the external walls.

**Photo 26:** Merchants House: Wall plate no.1 built into the external walls.

**Photo 27:** Merchants House: Wall plate no.1 built into the external walls.

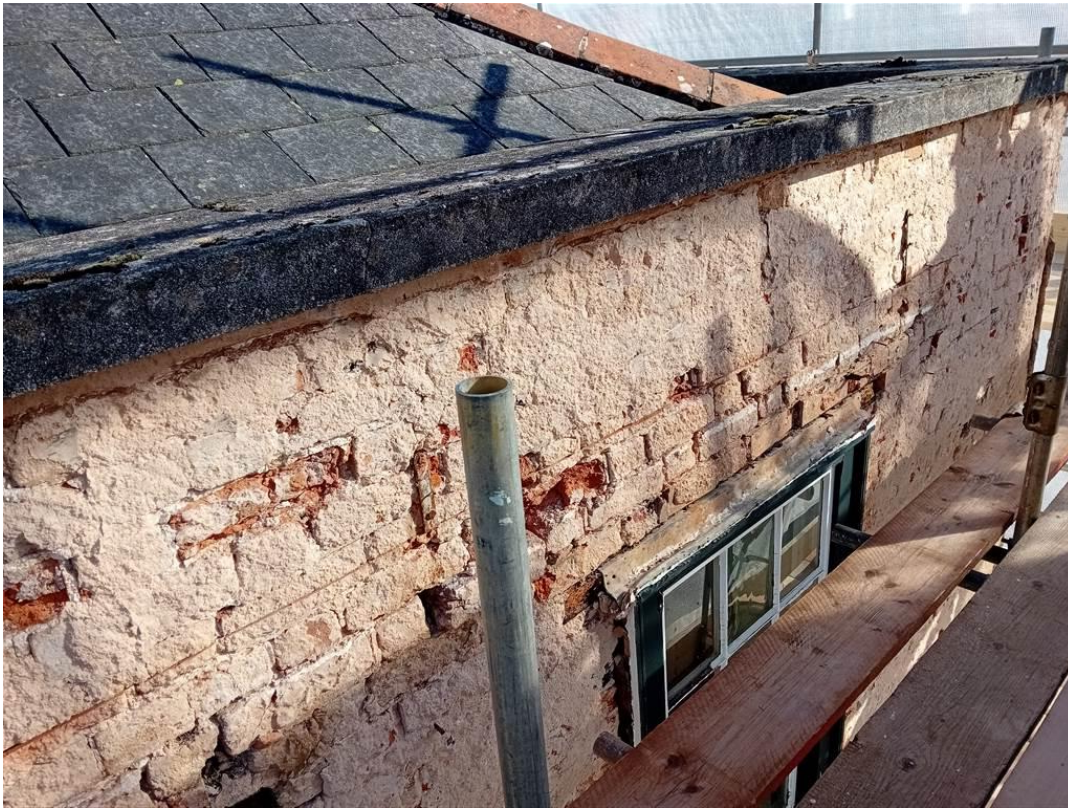
The front elevation parapet wall above windows W5 & W6 is in poor condition, caused in part to the movement and / or replacement of the lintels over the window openings. See Photo 29.

**Photo 29:** Merchants House: Front parapet wall with unstable brickwork.

The proposal is to carefully remove the copings, dismantle the brickwork down to window head height, cleaning off and setting aside the bricks for reuse. The wall will then be reconstructed back to the existing profile, incorporating the replacement of lintels included in the above item 5.3.4, and reinforcement as referred to in item 5.3.5.

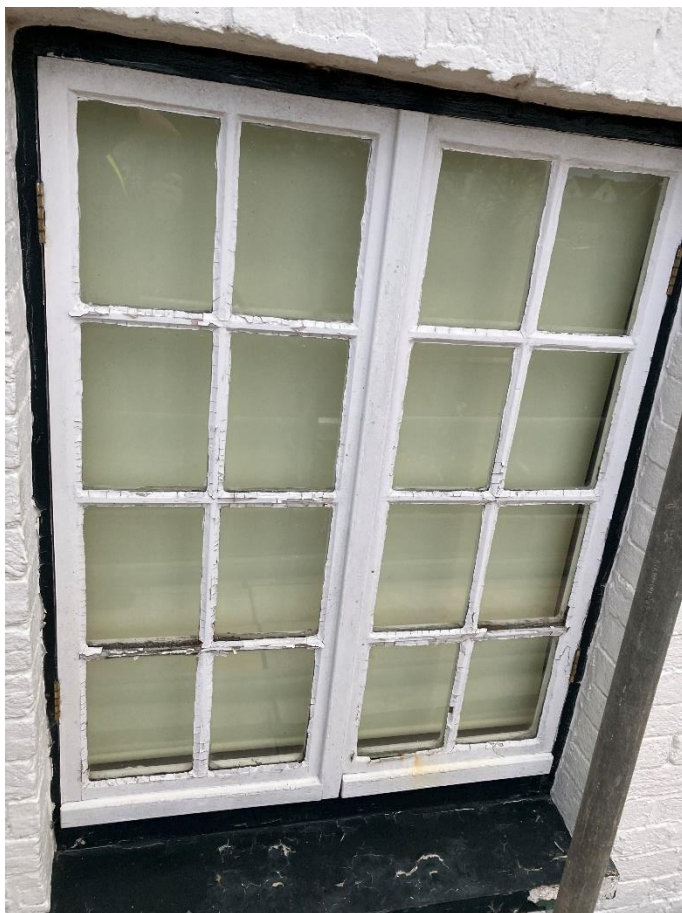
The first-floor windows facing the courtyard with window numbers W34 to W39 are considered to be in particularly poor condition, are draughty and are known to leak. Whilst repairs are feasible, they are beyond economic repair, and their full replacement is preferred. See Photo 30.

**Photo 30:** Victorian Sail Loft: Typical external windows W34 to W39.

It is proposed these windows are replaced with new timber windows to the same design but marginally deeper to allow the installation of 14mm thick double glazed sealed units, complete with full timber glazing bars. The glazing to incorporate a solar controlled coating to help address problems of over-heating in the first-floor sail loft. See drawing SWN-XX-00-D-B-010-P1 for section details of the proposed windows.

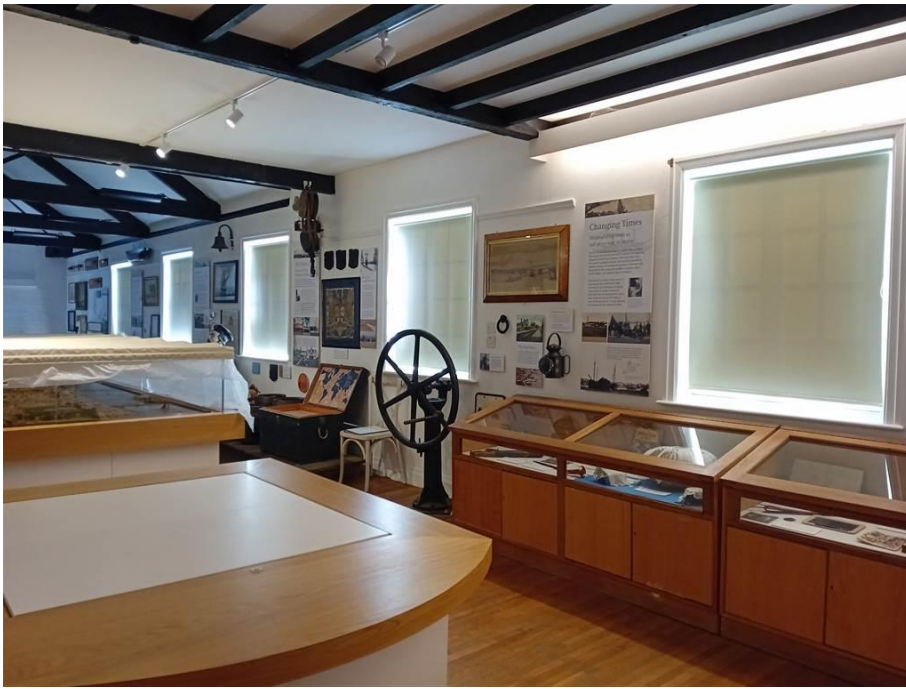
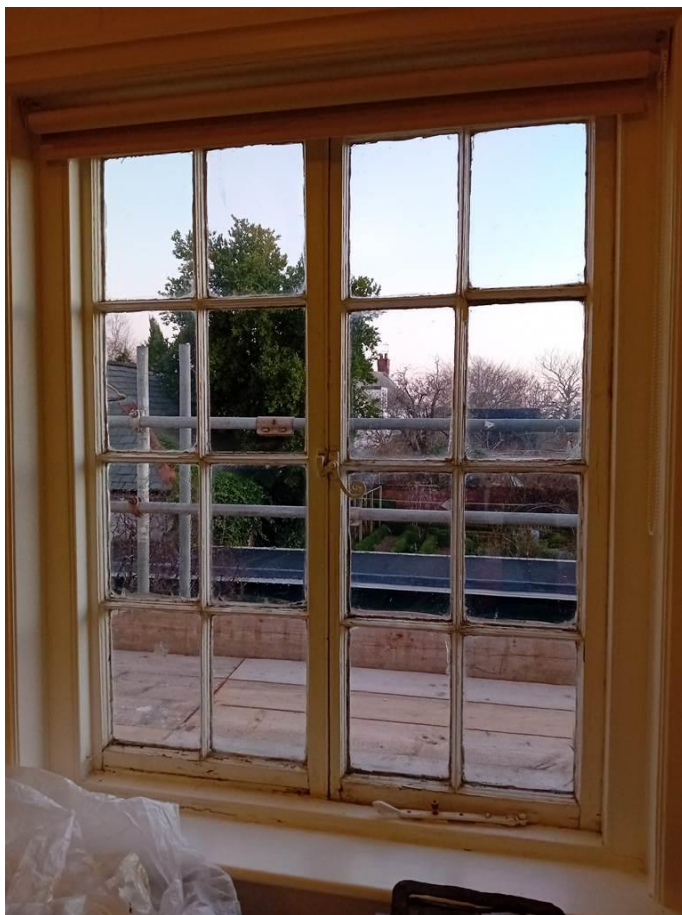
**Photo 31:** Victorian Sail Loft: Internal view with windows W34 to W39 behind roller blinds

**Photo 32:** Victorian Sail Loft: Typical internal view of external windows W34 to W39
